Viewing of the ROV video to MS Estonia

Date and location: 18.09.2020. Oslo, Norway

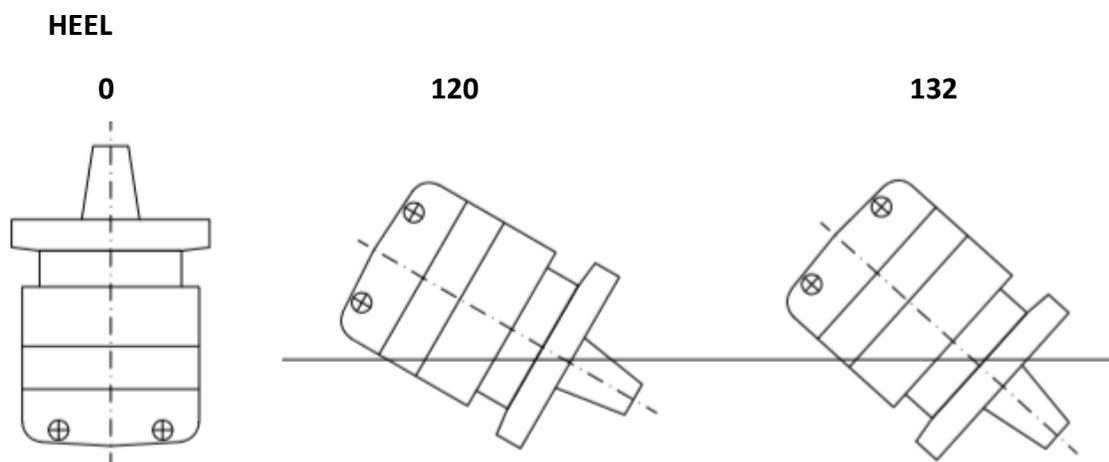
Initially the videos that will be publicly released on 28th of September were shown. Video starts with the claim that after the accident MS Estonia was laying at the sea bottom with the list of 120 deg and by now, the list is has increased to 132 deg, see the figure below. Thus, the starboard side of the ship has been partly lifted from the sea bottom and the starboard can be observed with ROV.

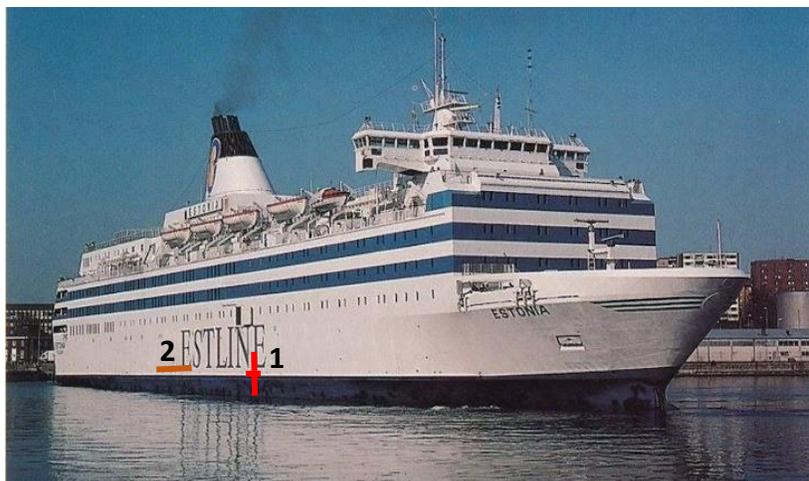
In the video, the ROV was moving along the ship hull, seemingly approaching from the bow towards the amidships. The camera was roughly moving along the side fender (*põrkepruss*) i.e. at the height of the car deck. **In the region indicated by red cross/line in the figure below, a penetration damage no 1 appeared.** The position was claimed to be about 98 from the aft of the ship, even though more realistic value seems to be about 90 m.

Depth of the penetration dent was claimed to be about 1.2 m and an obvious fracture was present. The fracture was a relatively straight vertical line with the height of about 4 m. Fracture seemed to follow a strong structural element such as web frame (*raamkaar*). According to ship profile view, the fracture extended from the car deck to the tween deck. In the middle of the vertical fracture, roughly at the location of the side fender and the car deck, the opening had a horizontal extent, which length was not directly presented, but appeared to be around 1 m. The penetration direction pointed slightly towards the bow. The penetration shape appeared to be kind of triangular, more arbitrary than symmetrical. Narrow strip of the steel structure had been bent outwards the ship hull. Based on the ROV images, a 3D expression of the damage opening and the fracture were constructed. In the vicinity of the damage opening, obvious longitudinal scratch marks were not noted.

Penetration damage no 1 has been caused by a force or object outside the ship causing the dent in the ship side structure. Steel plating was bent inward, except a narrow steel stripe that was bent outwards.

The characteristics of the penetration dent and the fracture were not typical for a blast opening nor for a man-made cut opening.

It is unlikely that the damage has been caused due to a collision at the sea surface. Direction of the penetration dent pointed slightly towards the bow. To cause such a damage, the penetrating object should have approached the ship from the stern (*after*), with its direction oblique (about 45 deg) with respect to MS Estonia. Also, the speed of the penetrating object should have exceeded the speed of MS Estonia.

Possible explanation for such damage could be a contact with an underwater object such as a seabed rock. Ship mass (12 000 ton) significantly exceeds the force required for the opening (500-1000 ton). Thus, an uneven surface under the ship side could introduce concentrated forces that could lead to penetration damages.

However, additional investigation could explain the reasons for the local penetration damage opening.

- Detailed scanning or video material from the sea bottom could reveal whether the bottom includes rocks of the size required to cause the damage (indication that such rocks exist in the bottom was revealed in the unofficial video footage).
- While relatively good image of the damage opening exists, more detailed information could be obtained by divers to measure and scan the damage opening.
- Numerical simulations can be conducted to analyse and explain the local penetration damage at the sea bottom.
- To exclude the surface collision scenario, plausible scenarios could be constructed that could lead to observed damage (establishing of relative directions and velocities between MS Estonia and penetrating object, and the required mass of the penetrating object). This would allow to assess, whether such collision scenario would be theoretically possible.

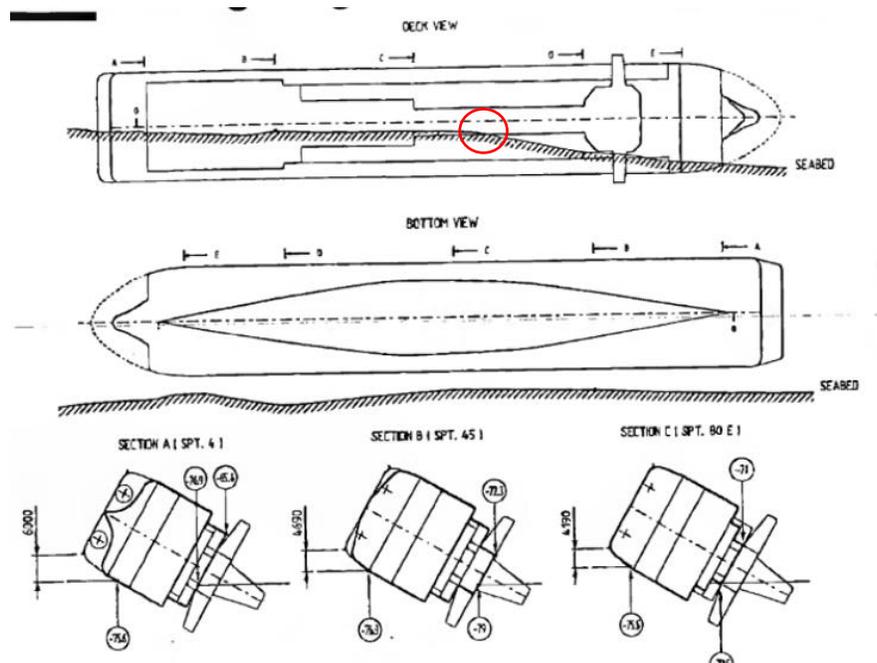
Survey report from 1994 presents the ship's position as it lays sideways at the sea bottom, see below. This position indicates that the slope of the sea bottom changes at about 1/3 ship length from the bow. This change in slope introduces higher loads in the region, where the damage was observed.
